Manhole Inspection Summary

Manhole # S25GG_018MH

Location Address: **565 DIVISION ST**

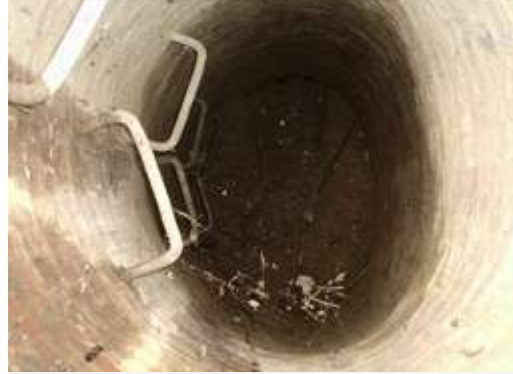
Top View

Corroded steps. Channel debris.

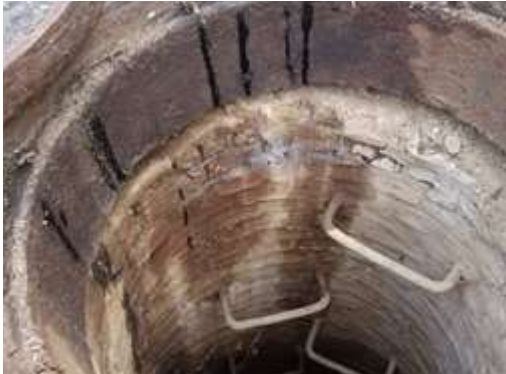
Defect

Frame leaks. Adjustment deterioration, loose brick and infiltration. Corbel and Barrel infiltration - other side.

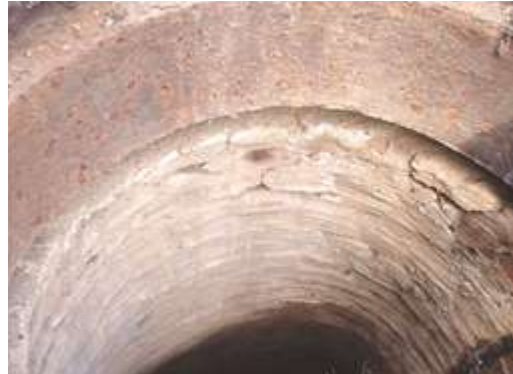
Defect

Frame leaks. Adjustment deterioration, loose brick and infiltration. Corbel and Barrel infiltration.

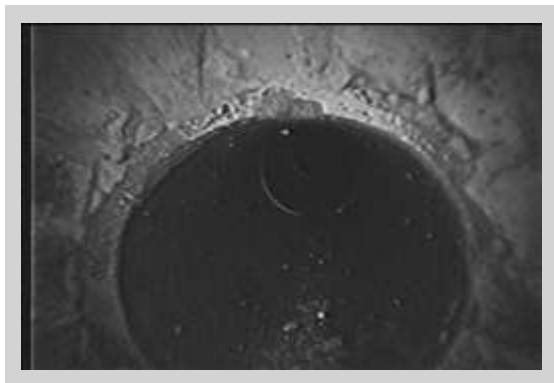
Pipe Out @ 12 O'Clock

Deposits: ☐ None ☒ **Mud** ☐ Sludge ☒ **Debris** ☐ Grease

Infiltration: **Evidence**

Pipe Seal Cond: **Cracked**
